Water Compliance Inspection Report

***NPDES
Inspection Report***

***Postma Dairy
Sumas, WA 98295***

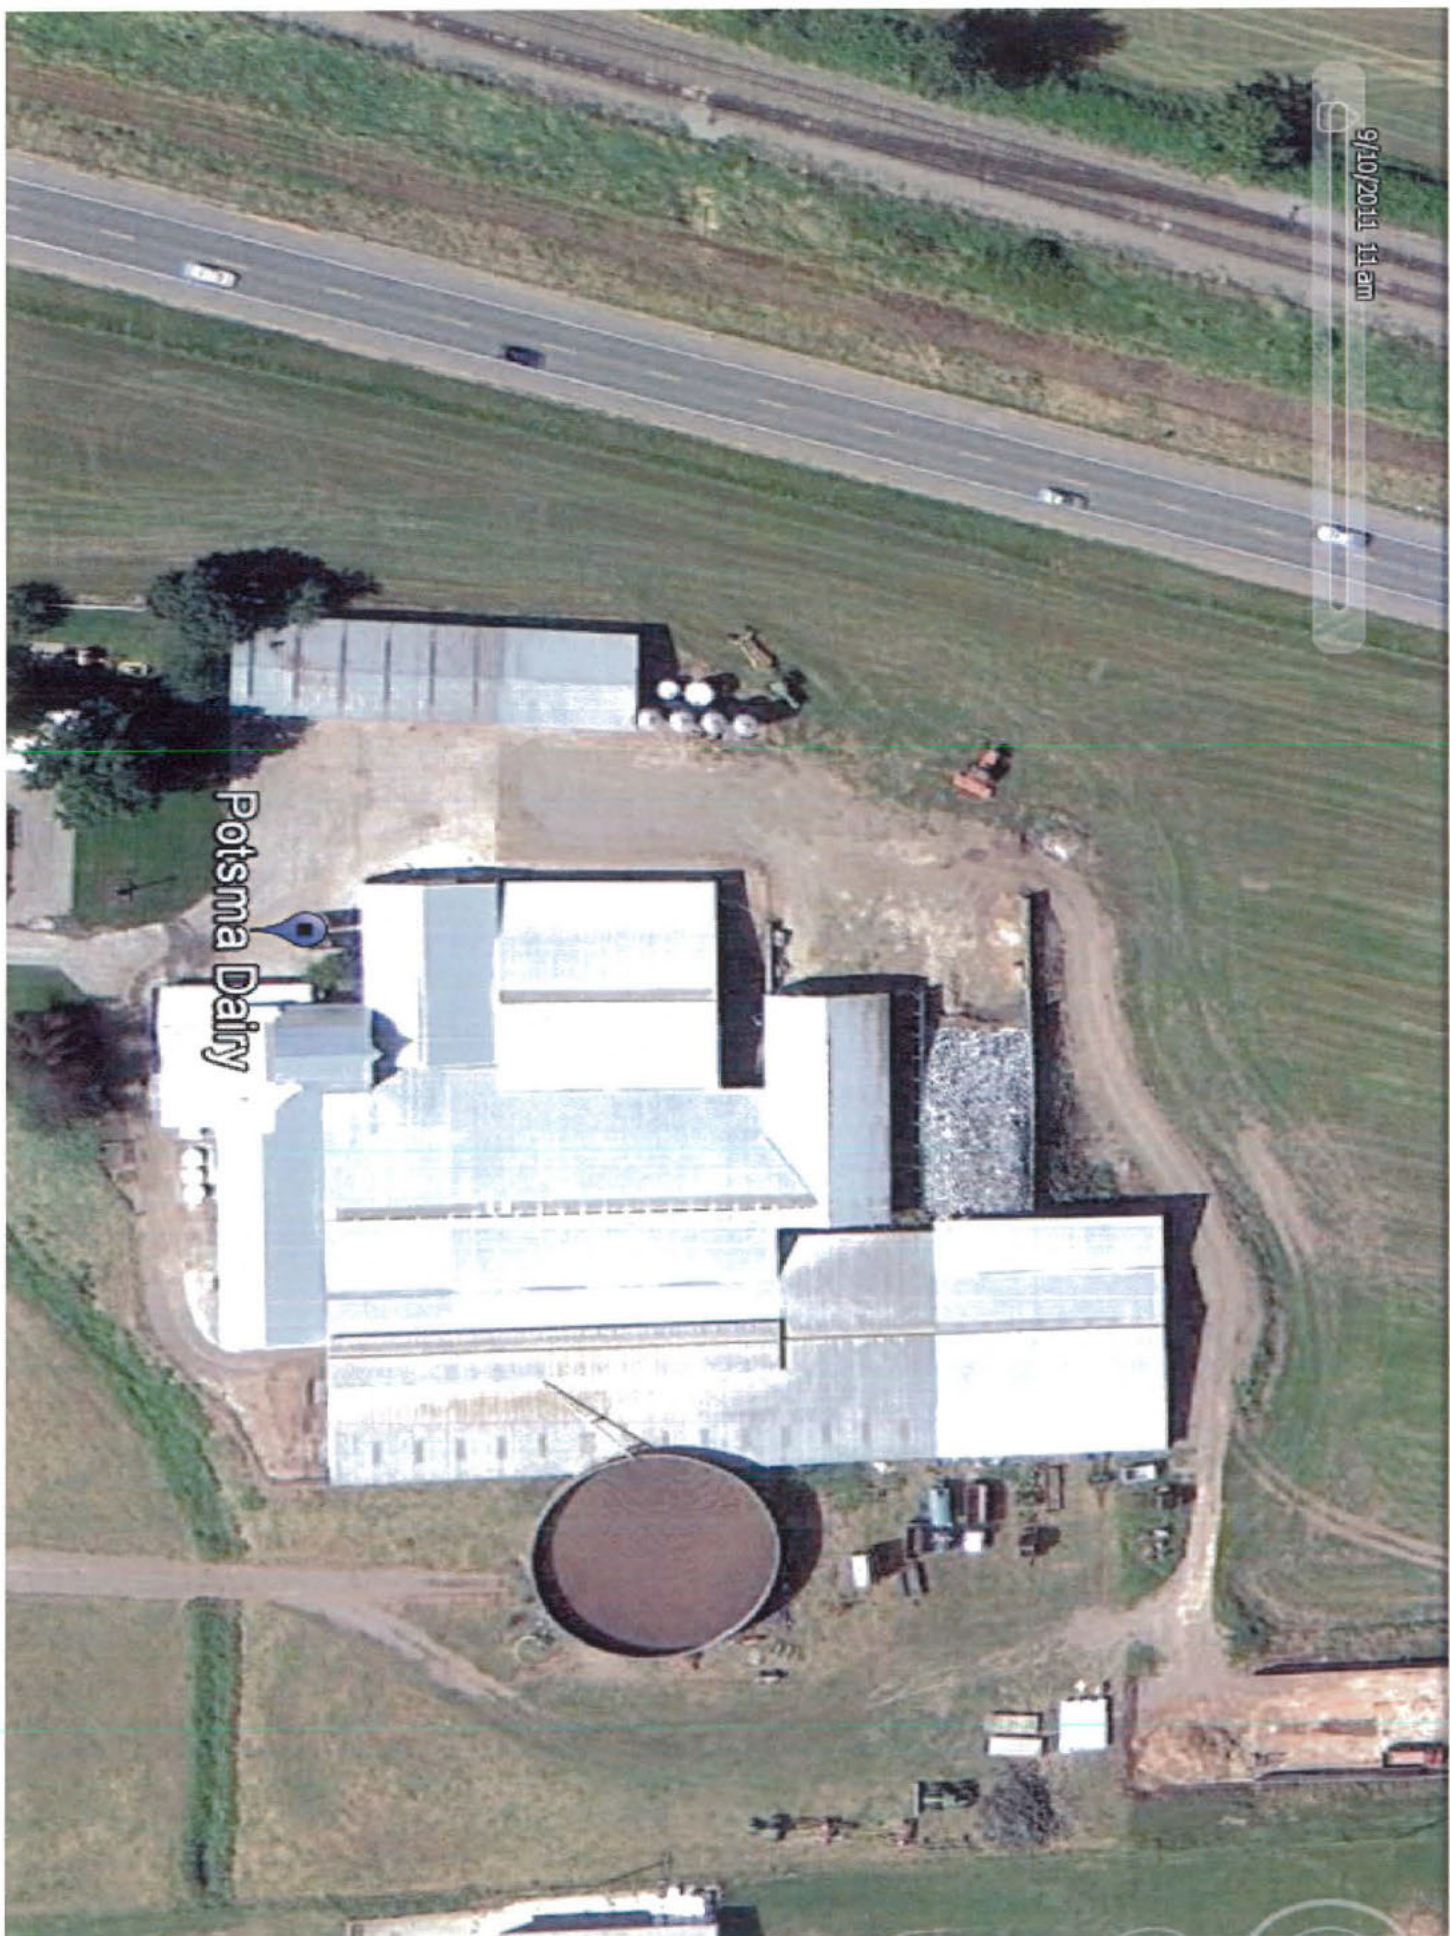
PHOTO # 1

Postma Dairy has confined animals in 3 separate locations. The main facility consists of a barn complex where animals are confined, fed, and maintained. It also includes a milk parlor, a silage storage area, a 30,000 gallon below ground waste storage tank, a 1 million gallon above ground waste storage tank, and adjacent pastures. See Attachment A, Aerial Photo #1.

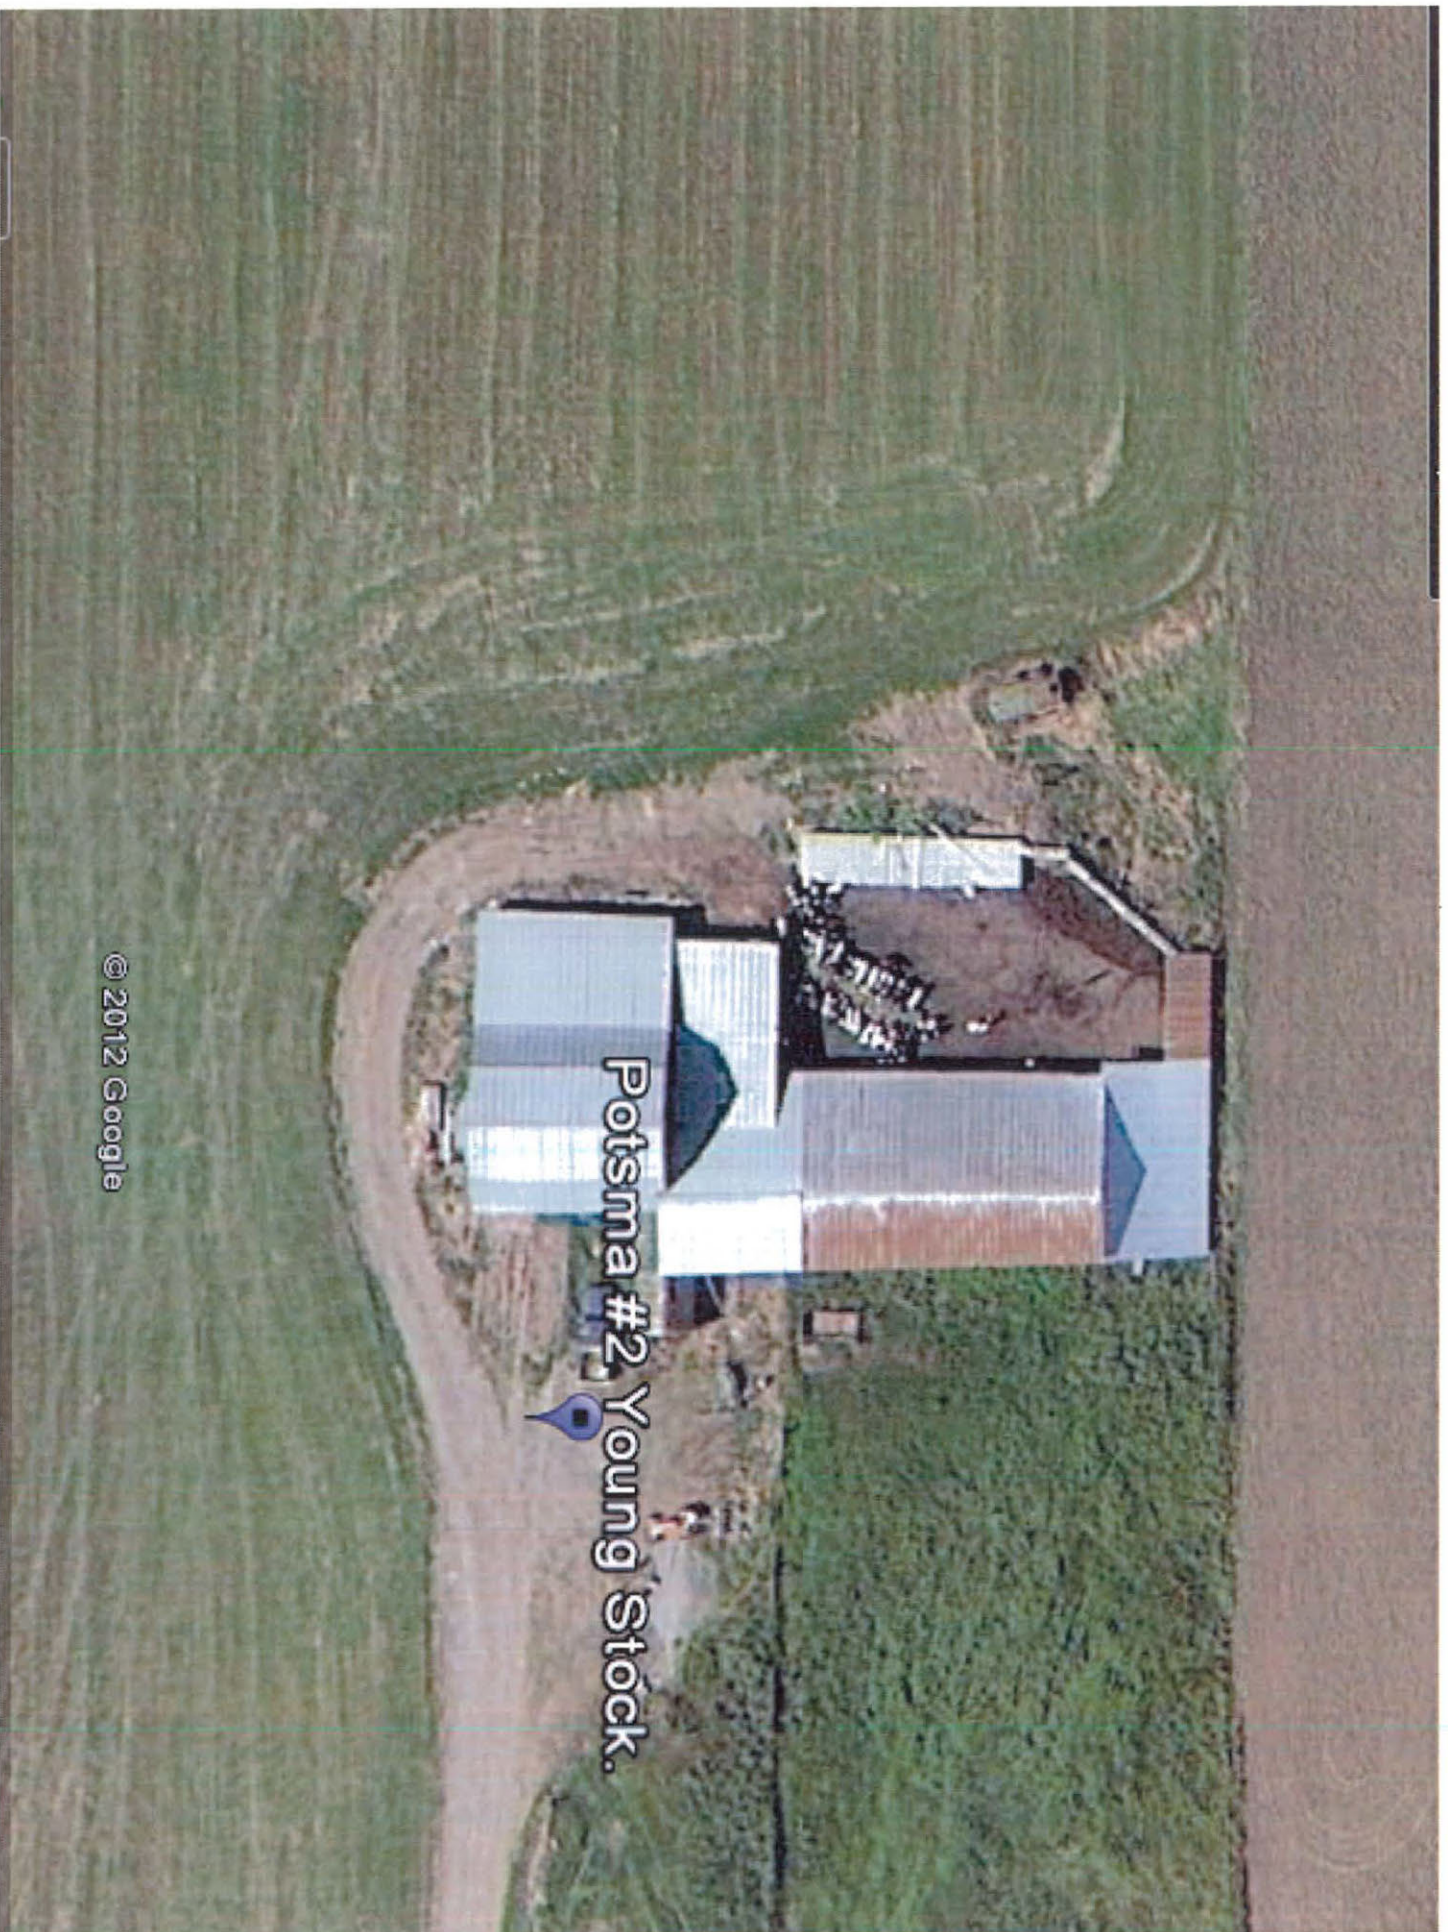
Potsma #2 Young Stock.

The second location is where the Dairy's young stock are kept. At the time of inspection 50-60 young, non-milking cows were at this location. The young stock facility consists of a barn complex where animals are confined, fed, and maintained. It also includes a 30,000 gallon below ground waste storage tank and adjacent pastures. See Attachment A, Aerial Photo #2

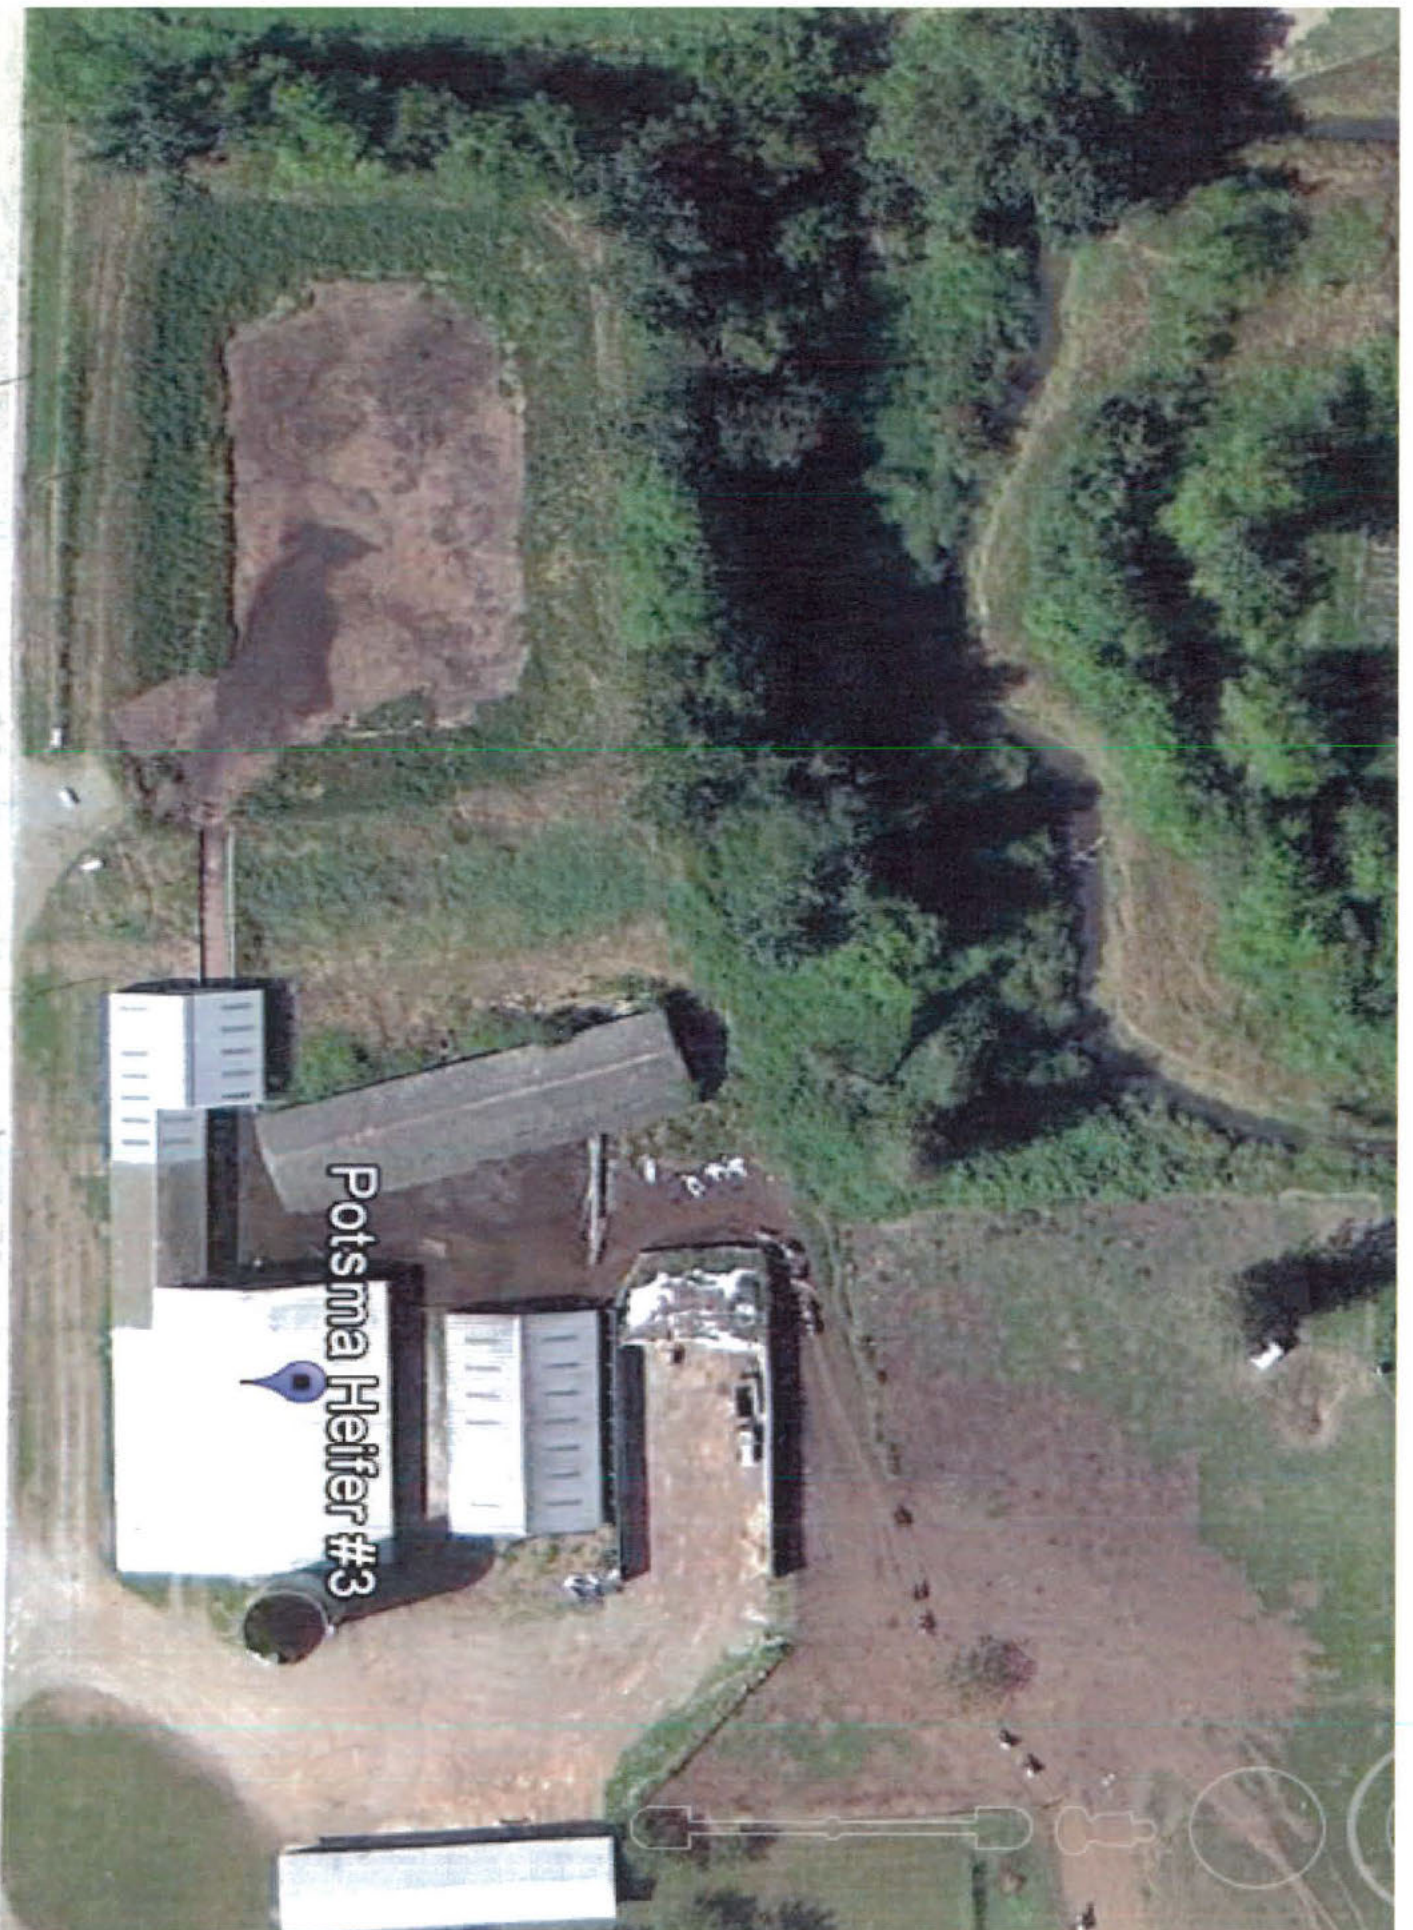
PHOTO #3

The third location is the Dairy's Heifer facility. At the time of inspection 240-250 heifers were at this location. The Heifer facility consists of a barn complex where animals are confined, fed, and maintained. It also includes a 30,000 gallon below ground waste storage tank, a 2 million gallon storage lagoon and adjacent pastures. See Attachment A, Aerial Photo #3.

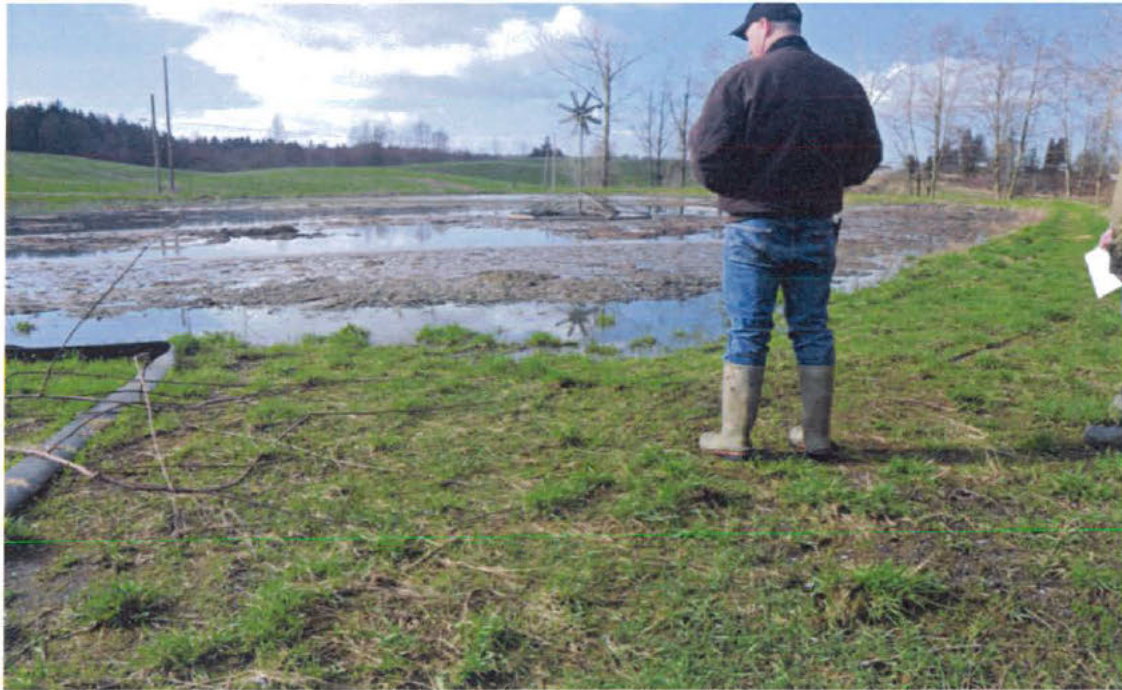
- A. Lagoon Capacity: At the time of inspection the facility's 2 million gallon waste storage lagoon was near maximum capacity. Roughly 2 inches of freeboard was remaining. This lagoon sits elevated about 50ft from the Sumas River. See Attachment B, Photo #1, Photo #2

Photo No. 1
Facing West, photo showing the waste storage lagoon at the time of inspection..

Mr. Postma stated he will not be adding anymore waste to the lagoon. Additional waste generated will be stored in the above ground waste storage tank which was verified to have about 12ft of additional storage in the 1 million gallon tank.

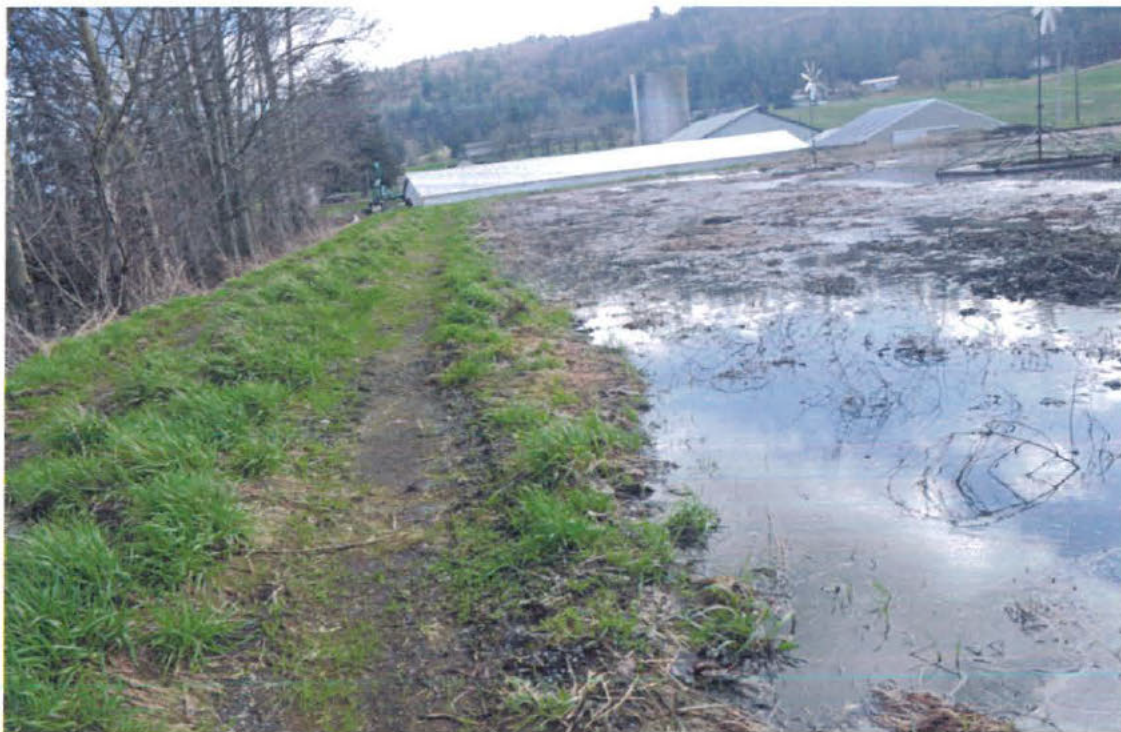
The receiving water with the highest risk at this facility is the Sumas River, located roughly 50 ft from the waste storage lagoon at the Postma Heifer facility.

Photo No. 2
Facing East, photo showing the waste storage lagoon's proximity to the Sumas River. The Sumas River is located down slope to the left of the trees about 50 ft away.
